Service Information Letter

Service Information Letter 2017-01
 Re: Over-torqueing Motor Stud Retaining Nuts
 Drawing Reference: 490016-1, Forward Blower Assembly
 (Partial View Shown, Renumbered for Clarity)

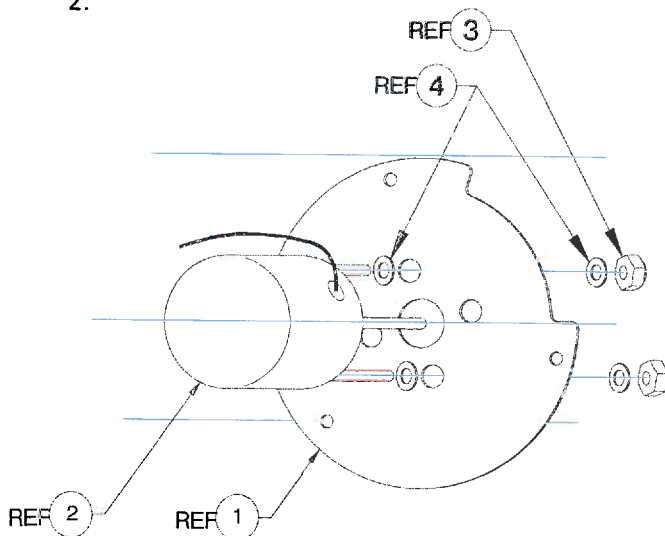
RSG Products has received reports of shortened service life of P/N 050052-1 Blower Motor. Investigation and analysis identified the cause as improper torqueing of the item 3 nuts that attach the item 1 Cover Plate Mod to the item 2 Motor during assembly.

Over-torqueing these retaining nuts leads to binding within the blower motor, which causes increased workload and a shortened service life.

When installing the item 3 nuts, do so in accordance with the following:

1. Thread the first nut onto the bolt until it just begins to make contact with the item 4 washer. Do not tighten further at this point.
2. Repeat Step 1 with the item 3 nut on the opposite bolt.
3. Returning to the nut installed during Step 1 and, using a dial-indicating torque wrench, apply an additional 10 in/lbs. of torque.
4. Repeat on the opposite nut.
5. Rotate the motor shaft. It should spin freely without any binding or restriction. If any binding is detected, slightly loosen both nuts and repeat Steps 1 through 4 with particular emphasis on ensuring that the nuts are not overly snugged during Steps 1 and 2.
