Service Information Letter

Service Information Letter SIL2017-01 Rev A
 Over-torquing Motor Stud Retaining Nuts
 Drawing Referring Motor Stud Retaining assembly
 (Partial View Shown, Renumbered for Clarity)

Issued: 8/29/2017
 Reissued: 12/15/2022

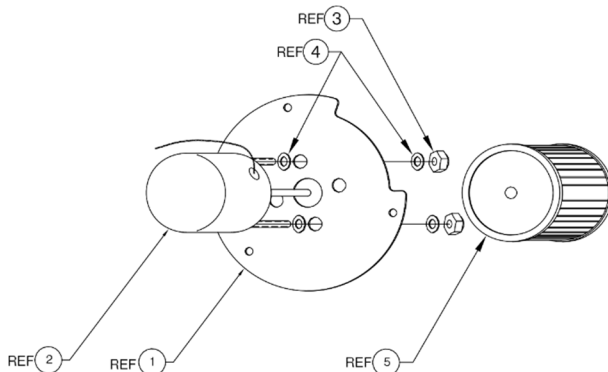
RSG Products has received reports of shortened service life of P/N 050052-1 Blower Motor. Investigation and analysis identified the cause as improper torquing of the item 3 nuts that attach the item 1 cover Plate Mod to the item 2 Motor during assembly.

Over-torquing these retaining nuts lead to binding within the blower motor, which causes increased workload and a shortened service life.

When installing the item 3 nuts, do so in accordance with the following:

1. Thread the first nut onto the bolt until it just begins to make contact with the item 4 washer. Do not tighten further at this point.
2. Repeat Step 1 with the item 3 nut on the opposite bolt.
3. Returning to the nut installed during Step 1 and, using a dial-indicating torque wrench, apply an additional 10in/lbs. of torque.
4. Repeat on the opposite nut.
5. Ensure .7 gap between cover plate item 1 and fan wheel.
6. Rotate the motor shaft. It should spin freely without any binding or restriction. If any binding is detected, slightly loosen both nuts and repeat Steps 1 through 4 with particular emphasis on ensuring that the nuts are not overly snugged during Steps 1 and 2.
