Service Bulletin

Service Bulletin #2018-01

Re: Initial and recurring Inspection of the Compressor Mount Bracket

Drawing Reference: 01-365-21-100

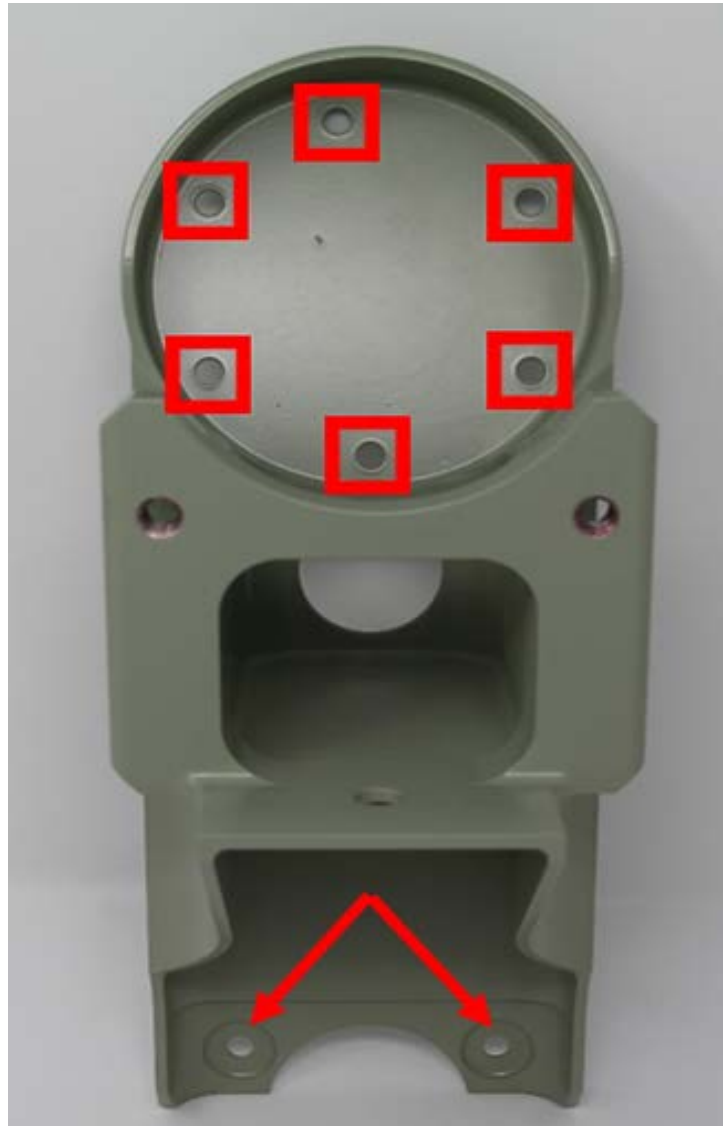
What: Gain access to the aft side of the MGB and locate the Compressor Mount Bracket, P/N 04-365-21-107-01.

Using an inspection mirror and an appropriate light source, inspect the 6 attaching holes at the top end of the bracket for any signs of cracking.

Next, inspect the two attaching holes at the bottom end of the bracket and adjacent to the tail rotor driveshaft for any signs of cracking.

See Figure 1 for inspection locations (highlighted in red).

If any signs of cracking are present at either of these locations, contact RSG Products immediately for replacement.

If a crack is present and it is equal to or less than .25" in length, it is permissible to accumulate a total of 5 additional aircraft flight hours prior to replacement.

If a crack is present and it is greater than .25" in length, immediate replacement prior to further aircraft flight is required.
